Final Completion Report – Reach 5B

Kress Creek/West Branch DuPage River Site and
the River Portion of the Sewage Treatment Plant
Site

**Final Completion Report –
Reach 5B**

Kress Creek/West Branch
DuPage River Site and the River
Portion of the Sewage Treatment
Plant Site

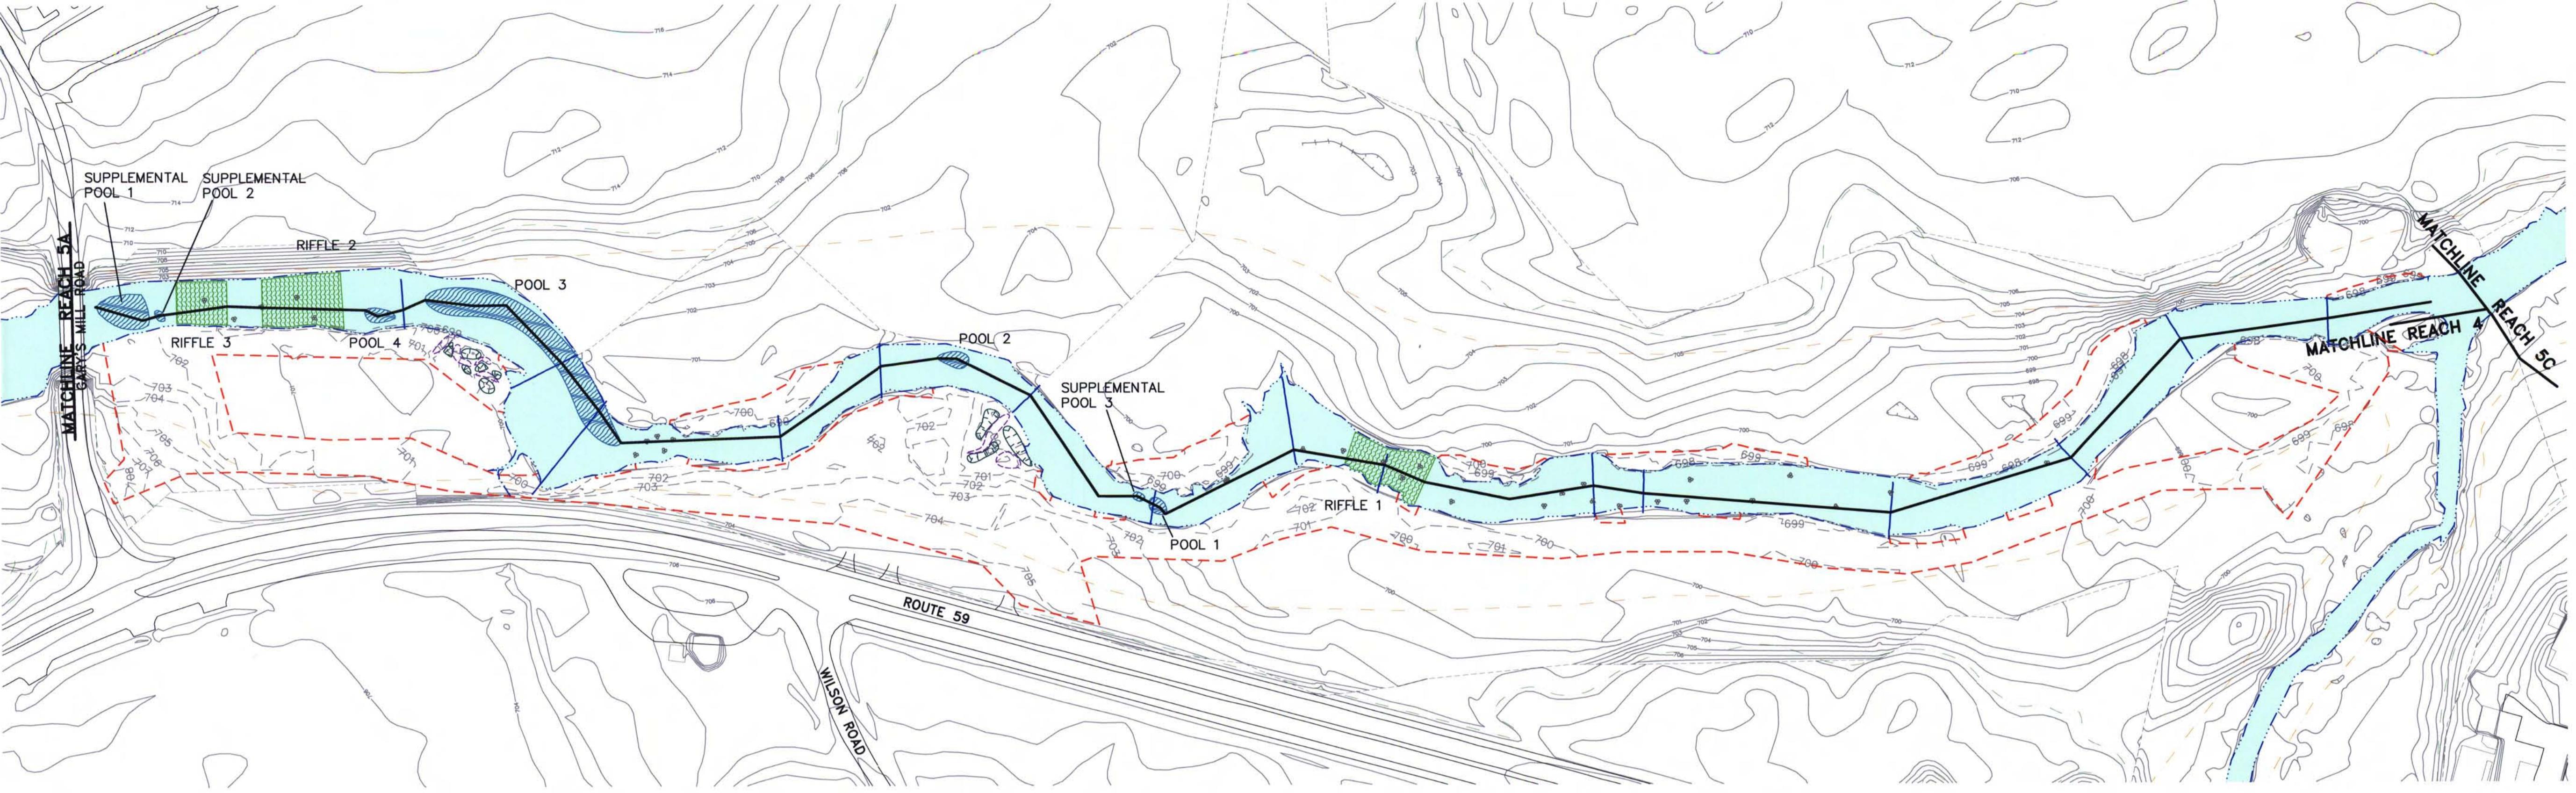
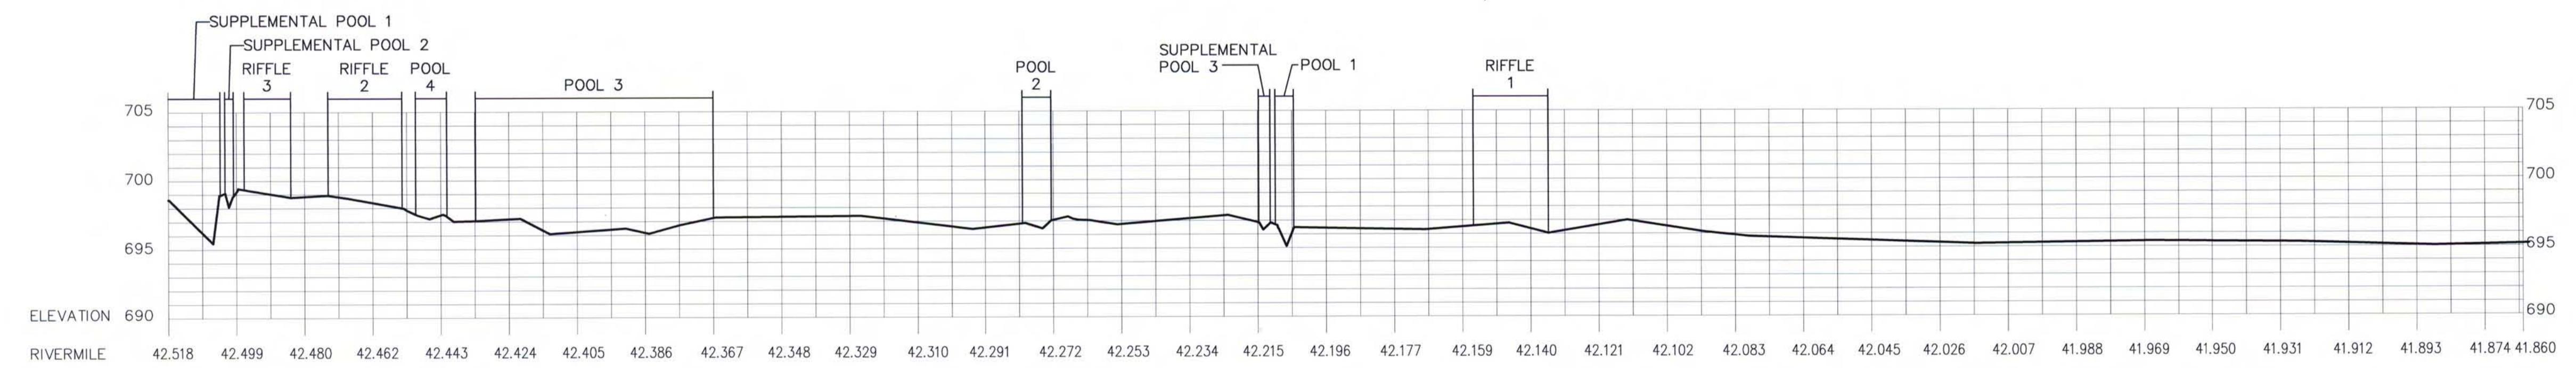
B-4

1. PROFILE GENERATED USING POST-CONSTRUCTION SURVEY DATA FROM POOLS, RIFFLES, AND TRANSECTS COLLECTED BY PROSOURCE TECHNOLOGIES, INC.
2. PROFILE ELEVATIONS GIVEN IN FEET ABOVE MEAN SEA LEVEL.

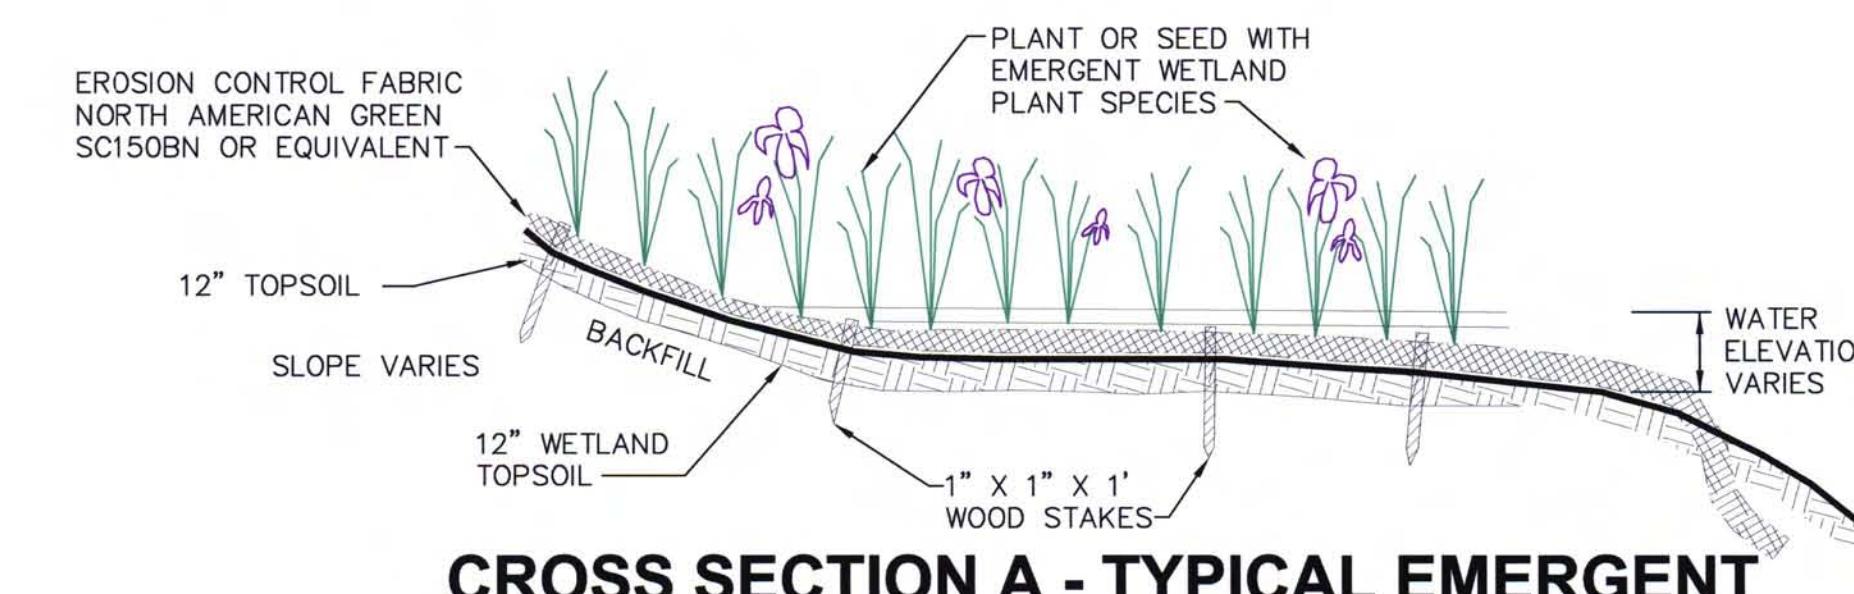
**CROSS SECTION A - TYPICAL EMERGENT
WETLAND BANK RESTORATION DETAIL**

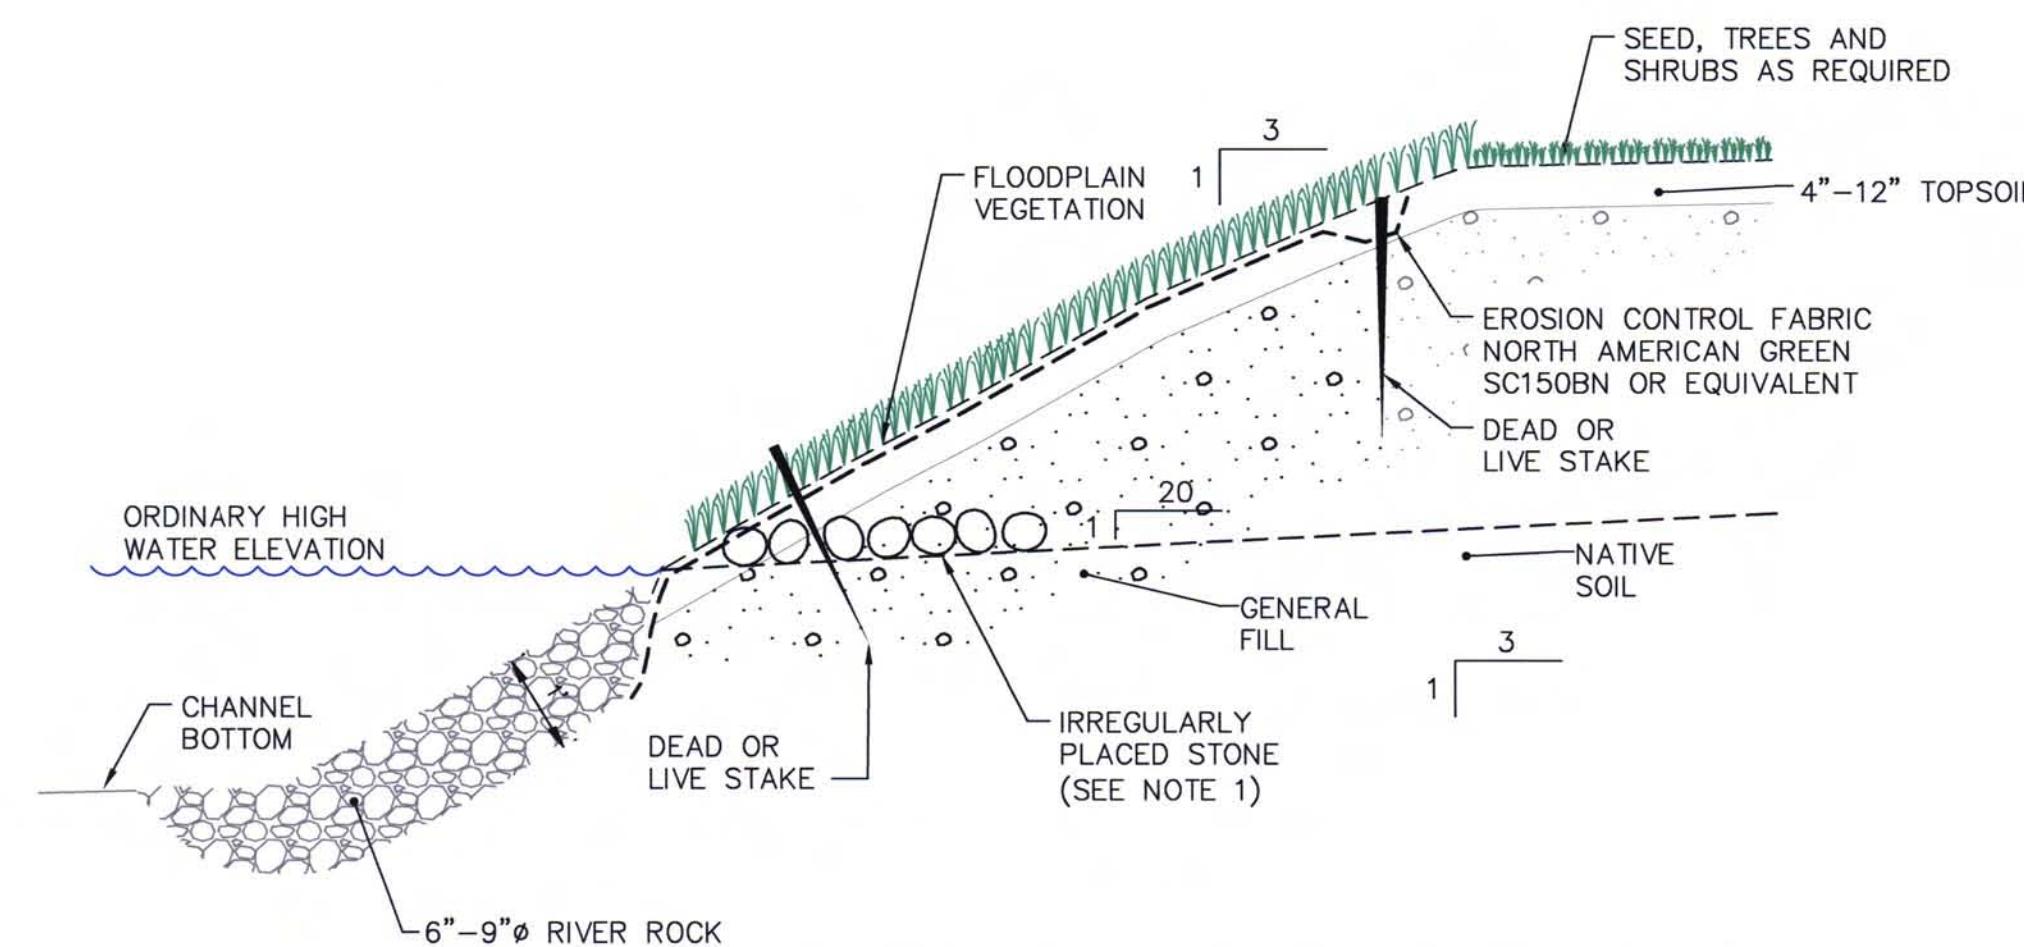
**CROSS SECTION B - TYPICAL
VEGETATED BANK RESTORATION DETAIL**

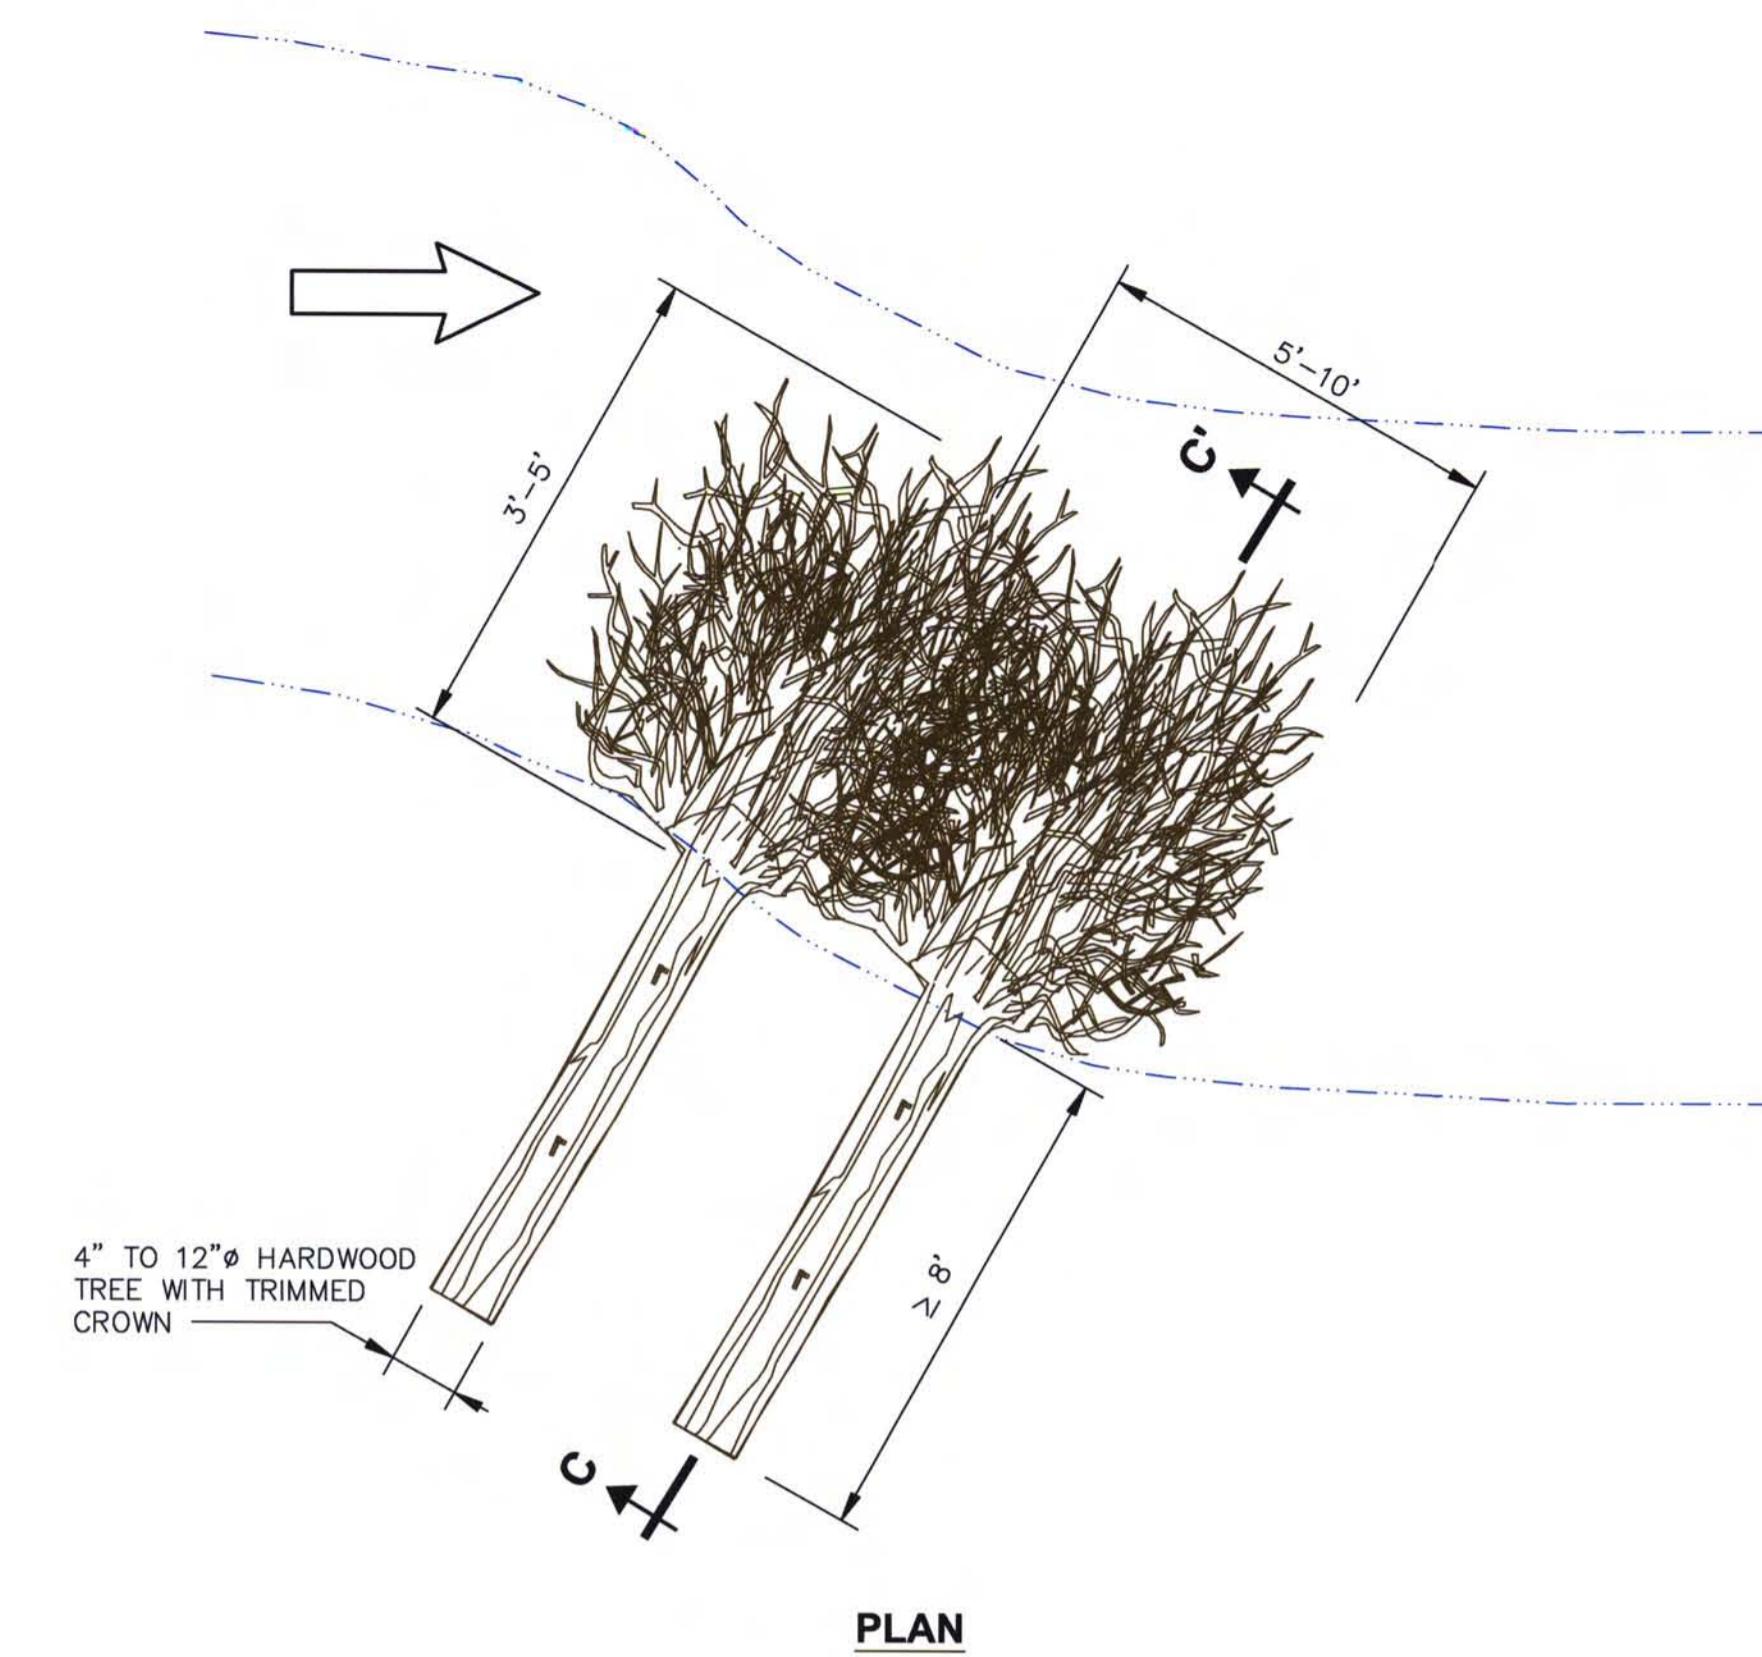
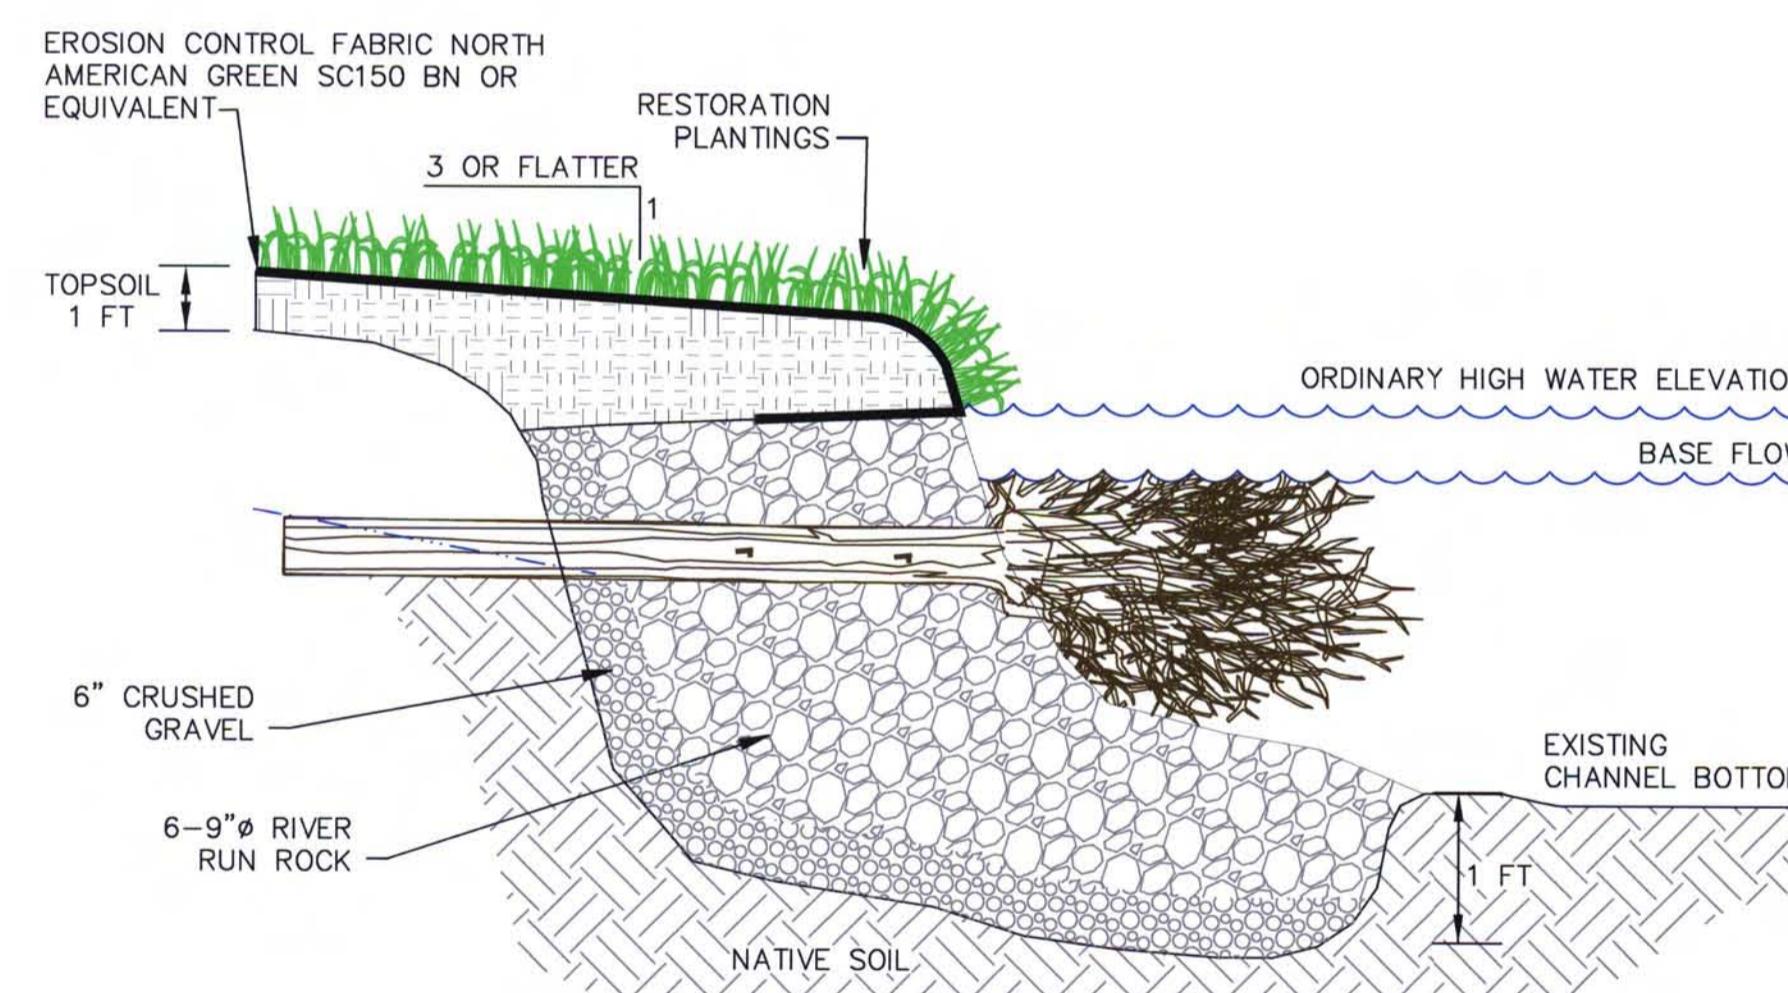
CROSS SECTION C - TYPICAL TREE CROWN HABITAT ENHANCEMENT

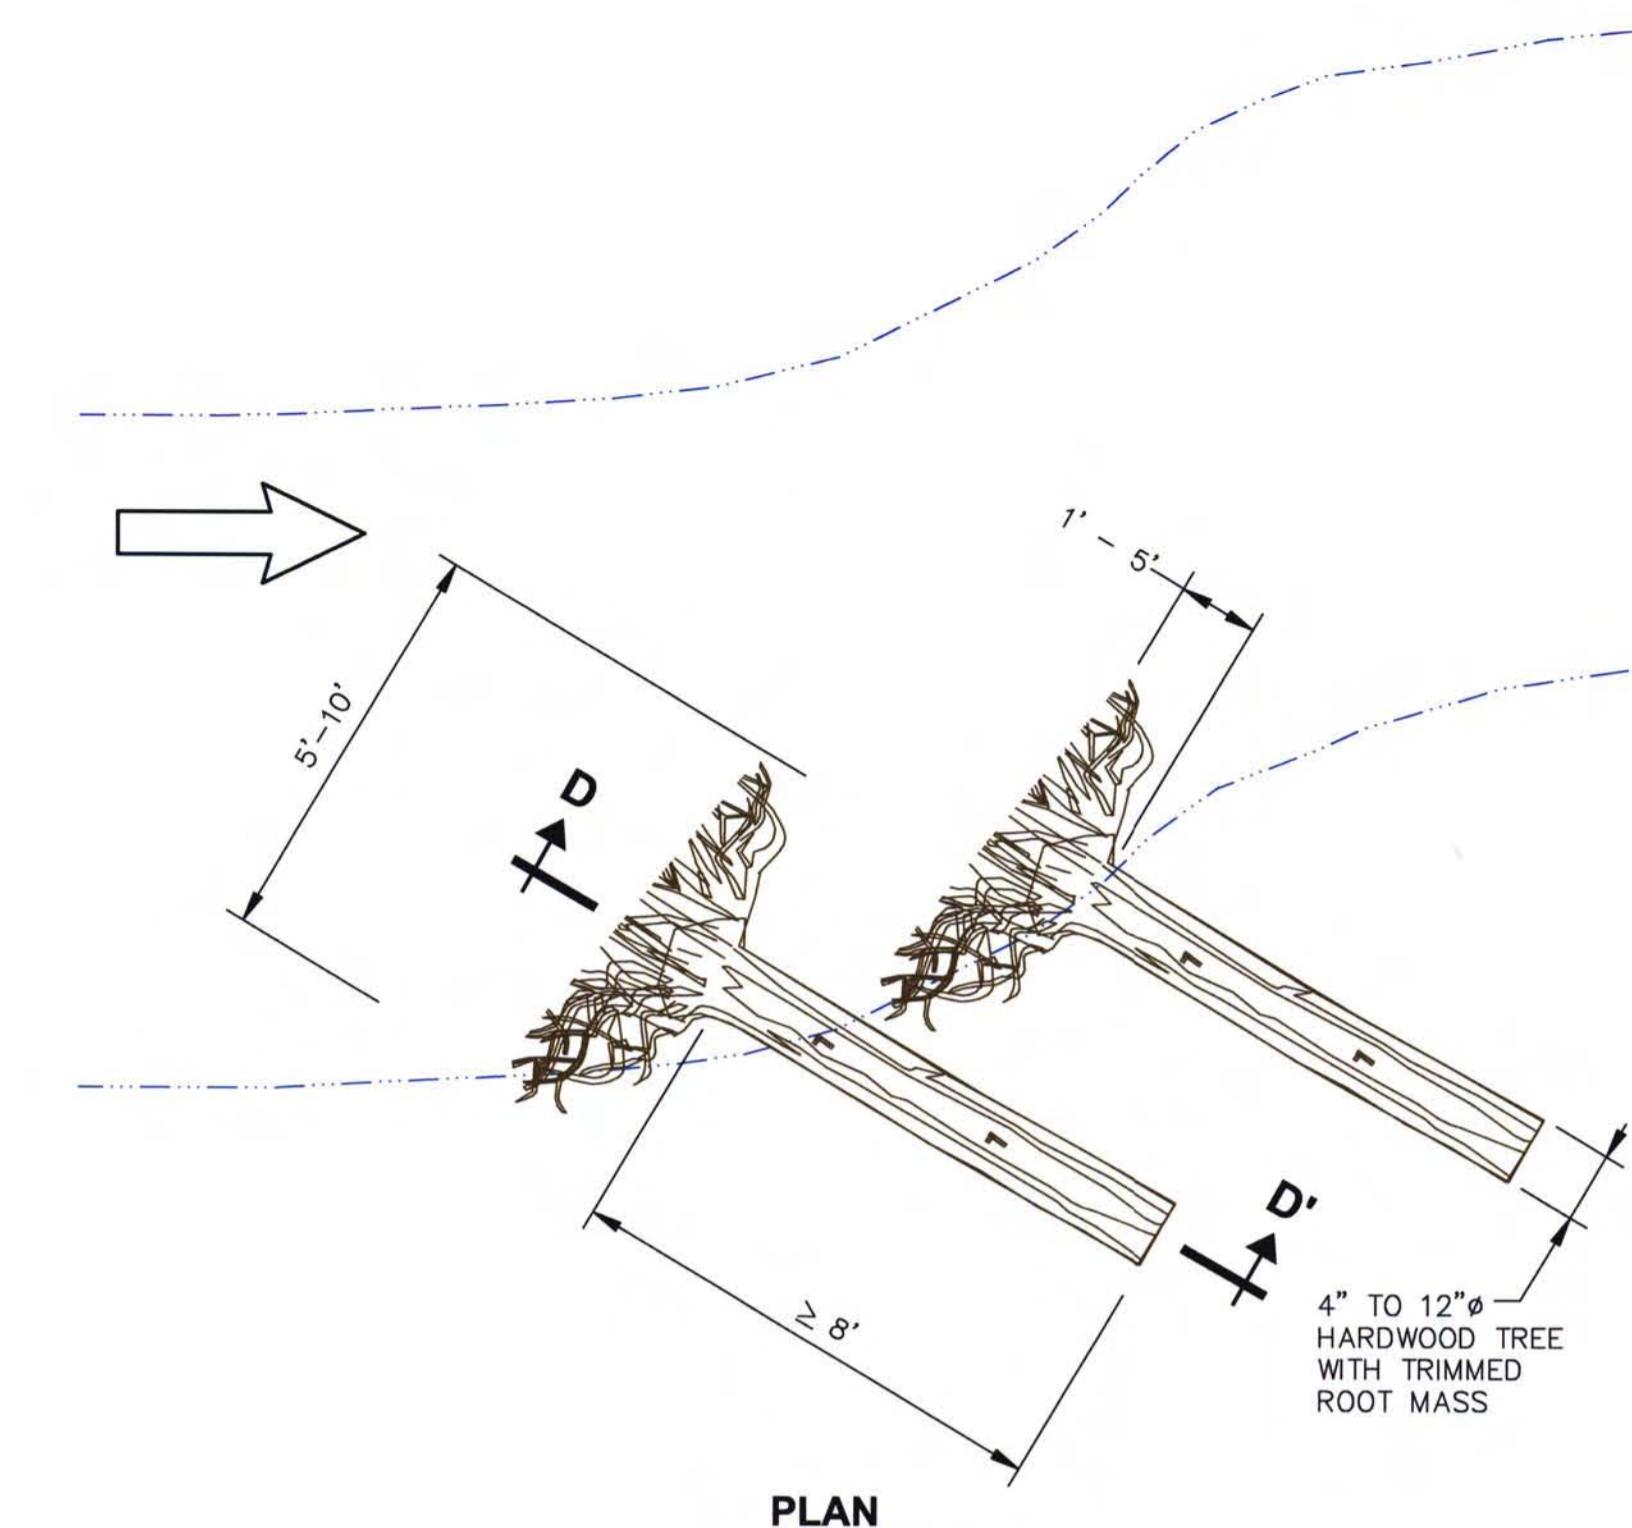
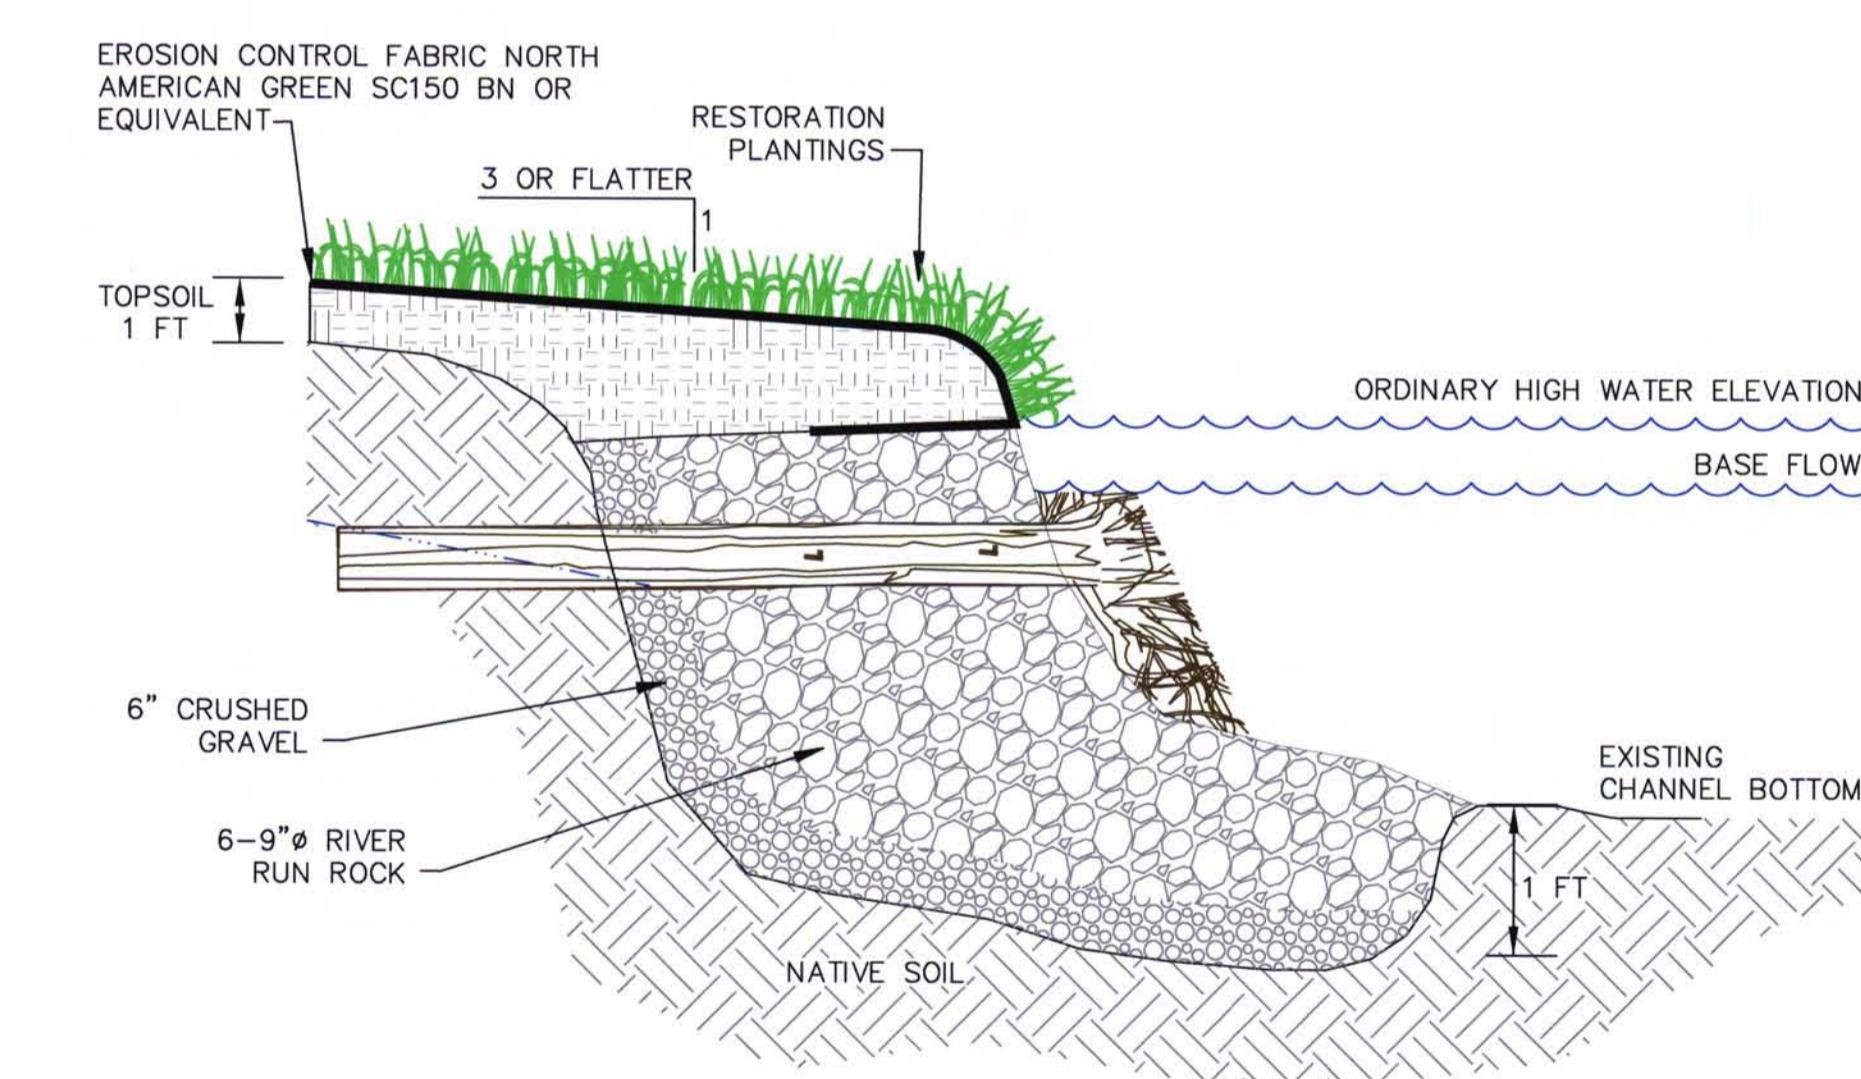
CROSS SECTION D - TYPICAL ROOT WAD HABITAT ENHANCEMENT

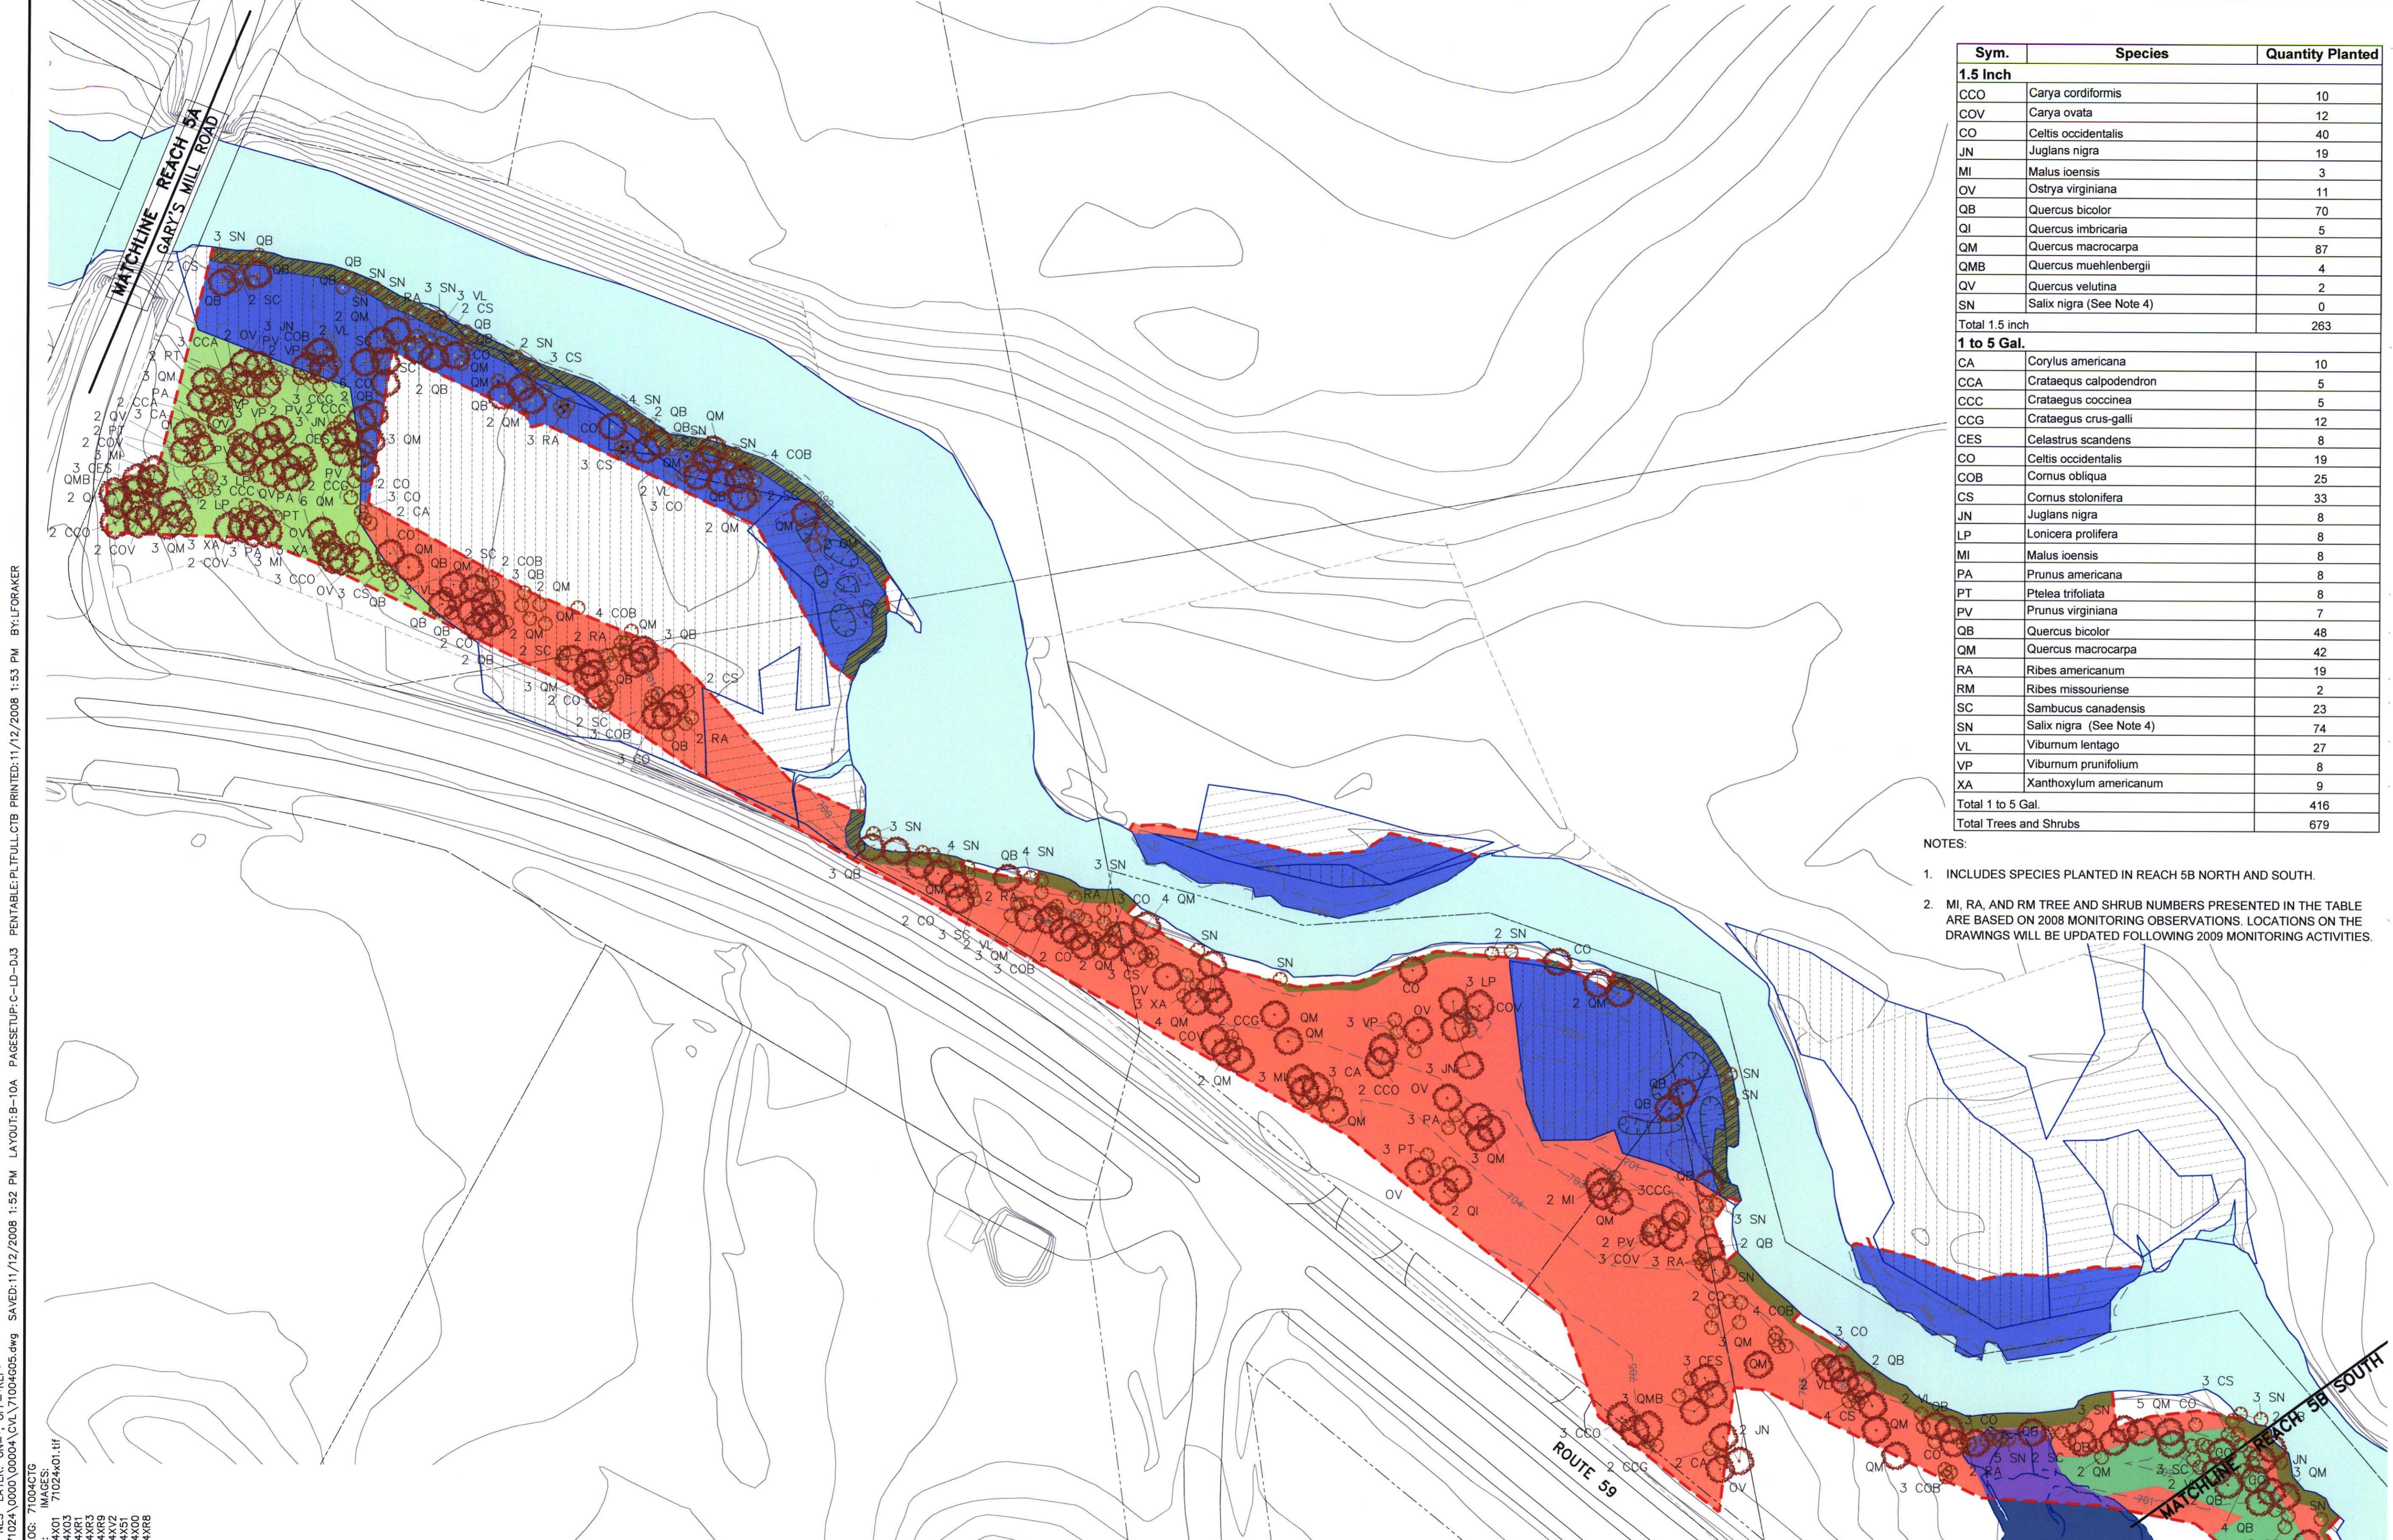
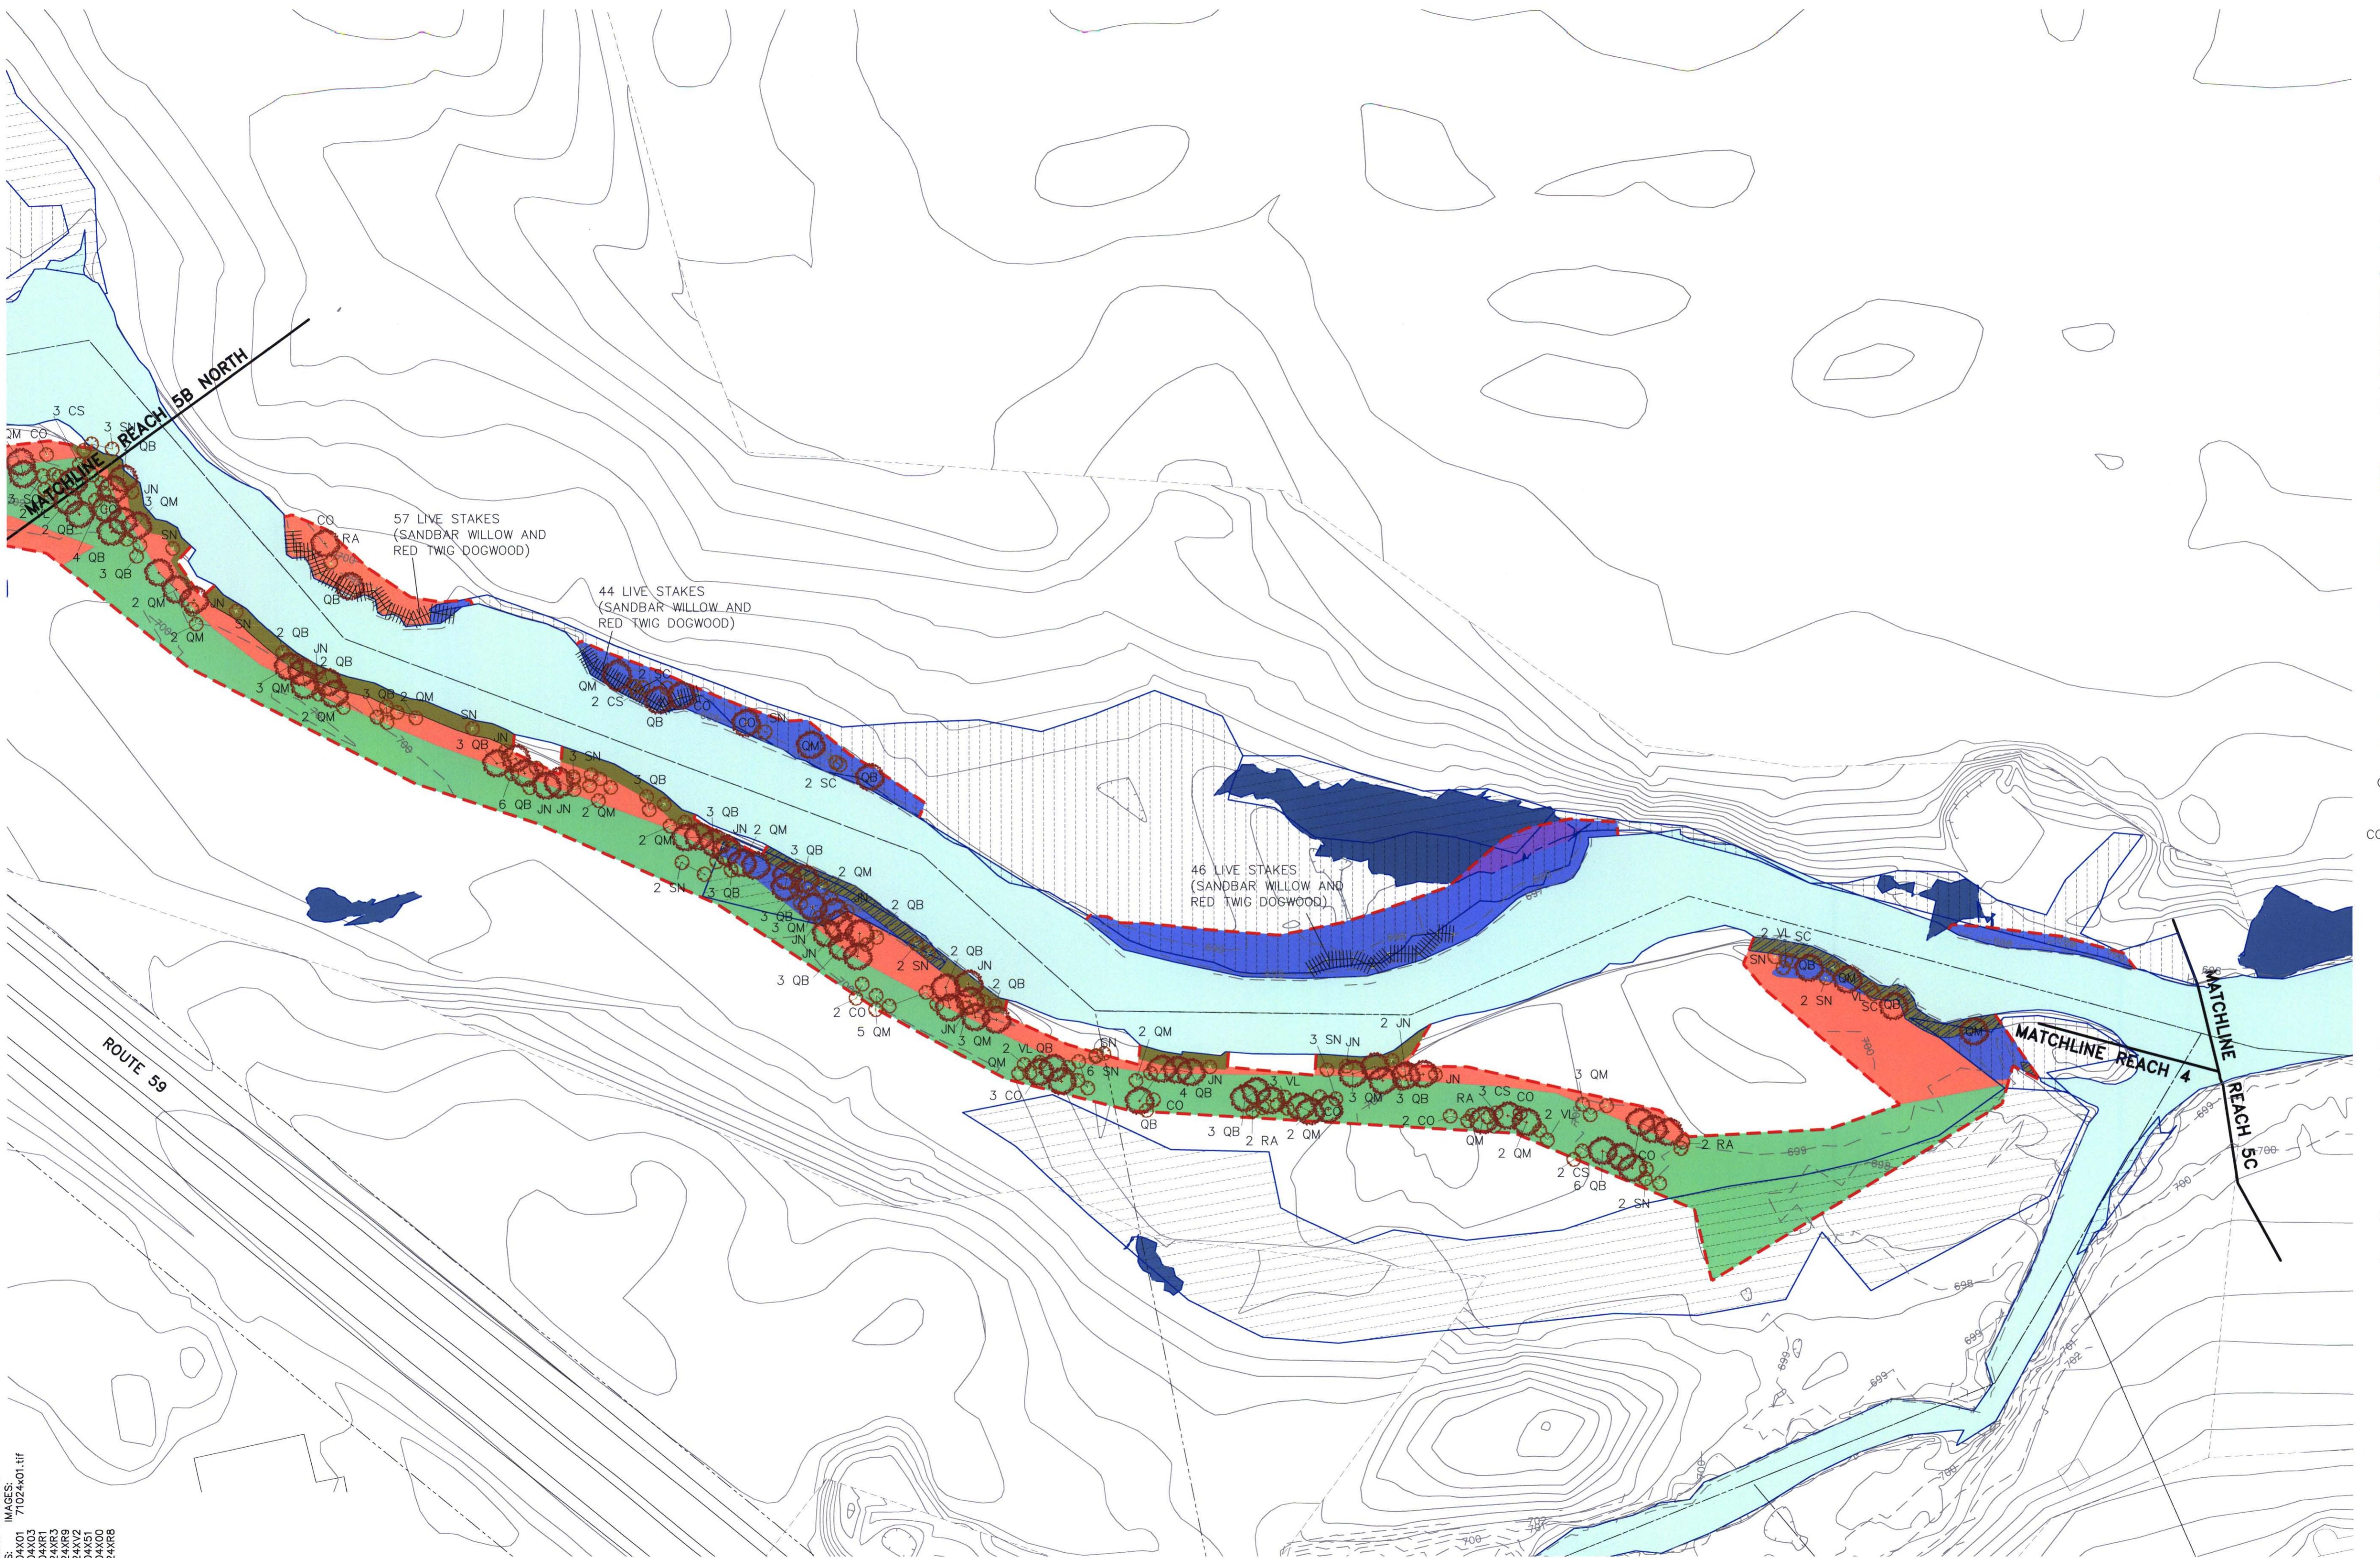
VEGETATION RESTORATION PLAN - REACH 5B NORTH

1. BASE MAP PROVIDED BY TRONOX LLC IN AN ARC VIEW PROJECT ENTITLED WEST CHICAGO KRESS CREEK. TOPOGRAPHIC LINES WITHIN THE LIMIT OF SURVEY LINE WERE DEVELOPED BY BLASLAND, BOUCK & LEE FROM SURVEY DATA PROVIDED BY PROSOURCE TECHNOLOGIES, INC., DUPAGE COUNTY, AND TRONOX.
2. ALL SHRUBS 1 TO 5-GALLON CONTAINER STOCK.
3. REPLACEMENT TREES 1.5" CALIPER ROOT-BAGGED STOCK.

△ 11/12/08	LEGEND AND TREE REVISIONS BASED ON 2008 RESTORATION MONITORING	MOG
△ 7/23/08	ADDED TREES AND SHRUBS IDENTIFIED AS MISSING DURING WALK THROUGH	MOG
△ 5/29/08	RECORD DRAWING	MOG
